# NatureMalta.com Preliminary Environmental Impact Assessment

## Reported impacts of the 1 June 2026 fireworks factory explosion in the Naxxar / Magħtab / Salina area, Malta

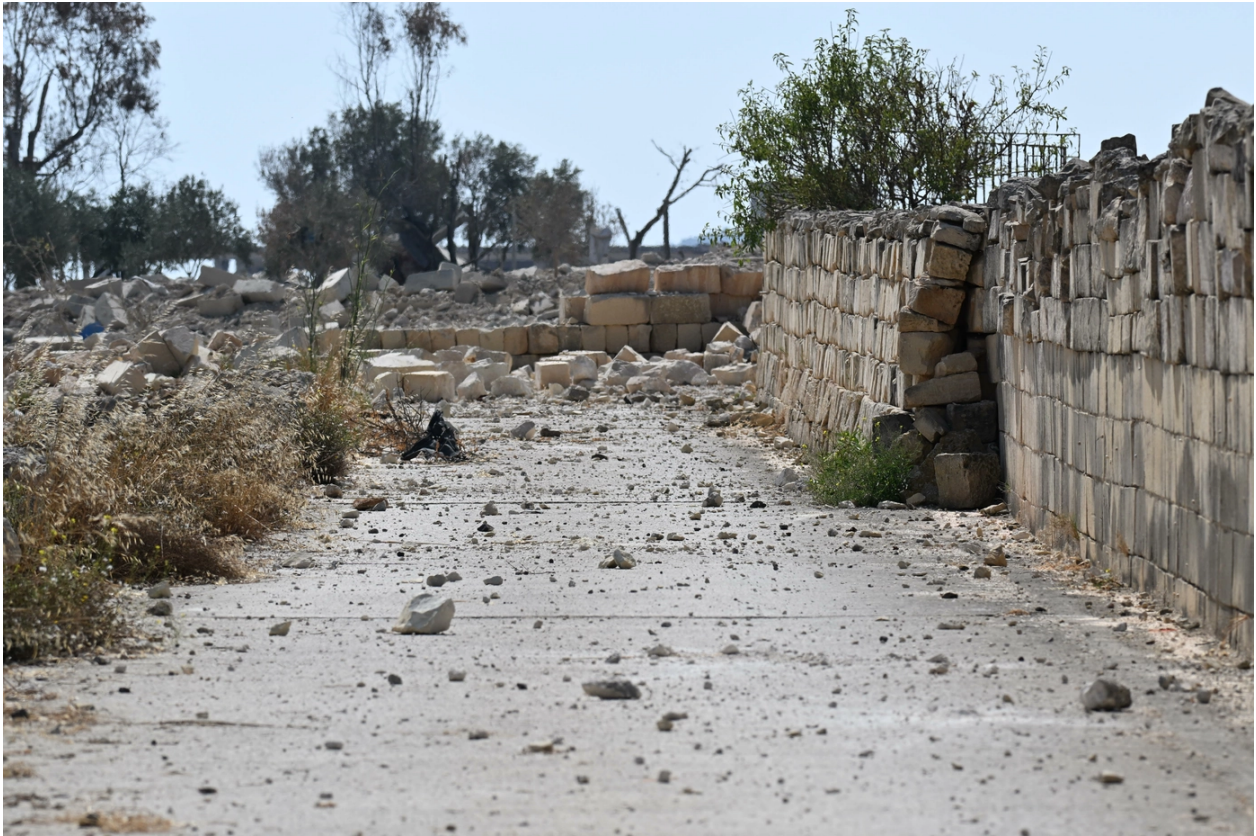
Figure 2: View from publicly accessible area near the police cordon No 1, 9 June 2026, showing visible blast-related debris/material dispersal close to the epicentre. Photograph: NatureMalta.com, 9 June 2026.

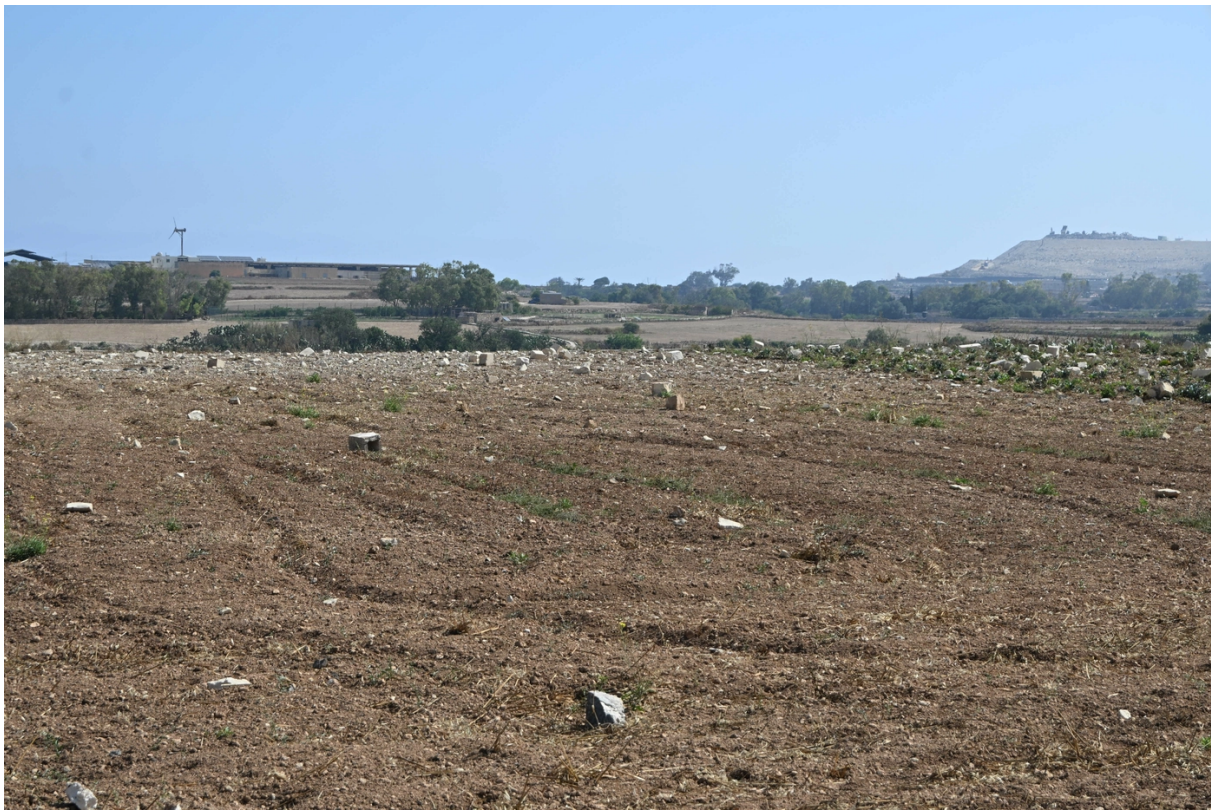
Figure 3: View from publicly accessible area, near to police cordon No 1, 9 June 2026, showing damaged structures in the wider affected area. Photograph: NatureMalta.com, 9 June 2026.

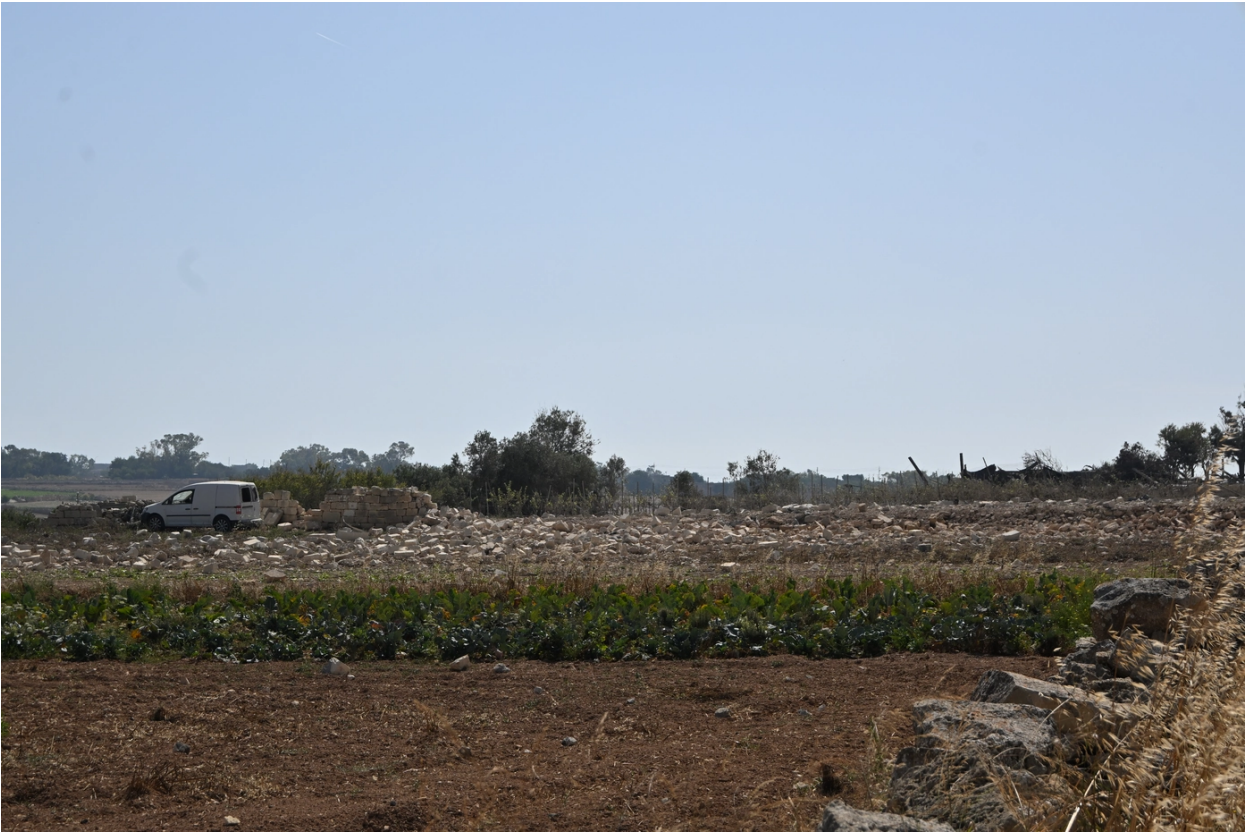
**Figure 4: Stone blocks displaced by blast force near the explosion epicentre.**

Large stone blocks observed from a publicly accessible area near to Police Point 1, on 9 June 2026, close to the restricted police cordon. The displacement of these blocks is consistent with significant blast force and material dispersal from the area of the fireworks factory explosion. The photograph records visible external evidence only; it does not confirm the exact origin point of the blocks, the full distance travelled, or the structural condition of the restricted inner site. Photograph: NatureMalta.com, 9 June 2026.

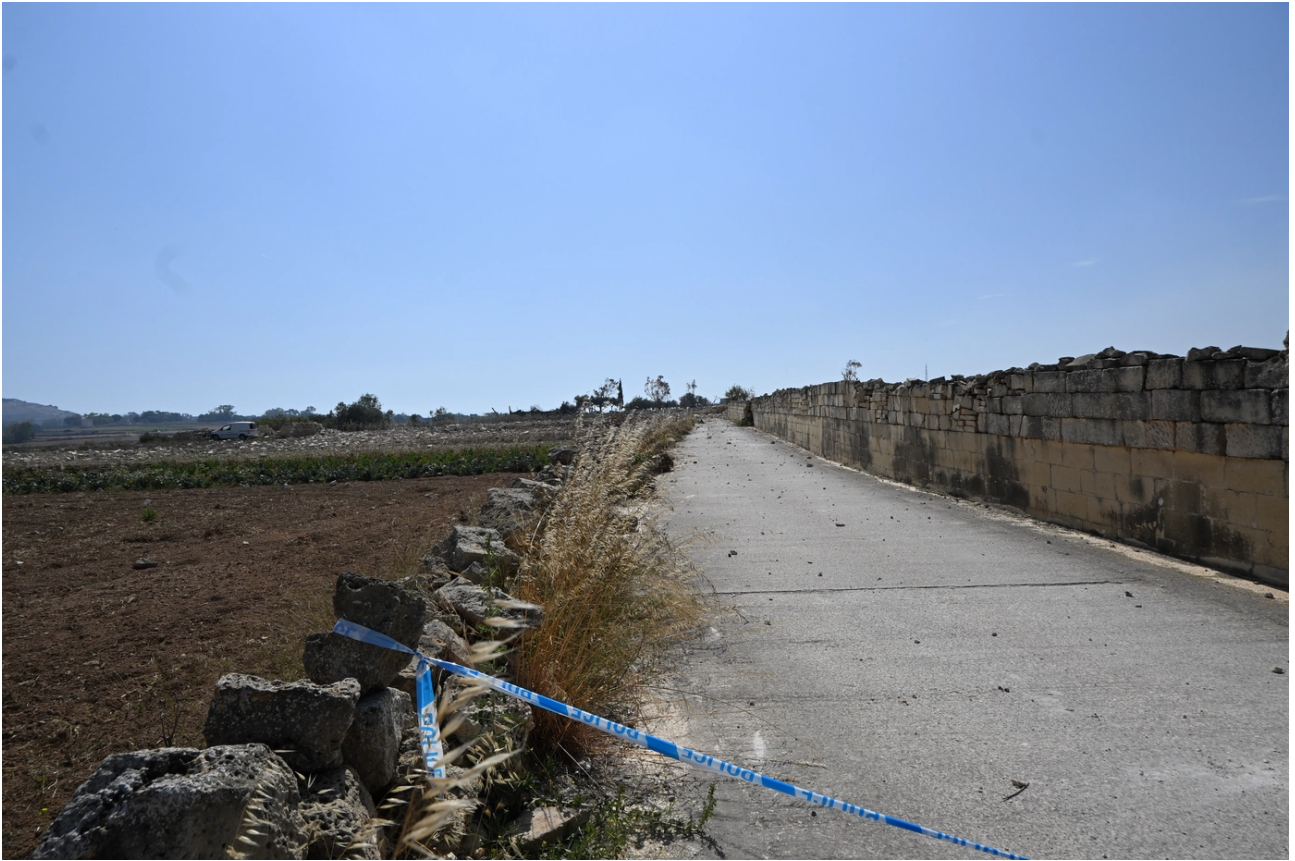
**Figure 6: General view towards the fireworks factory from Police Checkpoint No. 1.**

General view photographed on 9 June 2026 from a publicly accessible location at Police Checkpoint No. 1, looking towards the restricted fireworks factory area. The image provides wider visual context for the affected landscape, access restrictions, and visible external conditions following the 1 June 2026 explosion. The photograph does not represent access within the restricted inner site. Photograph: NatureMalta.com, 9 June 2026.

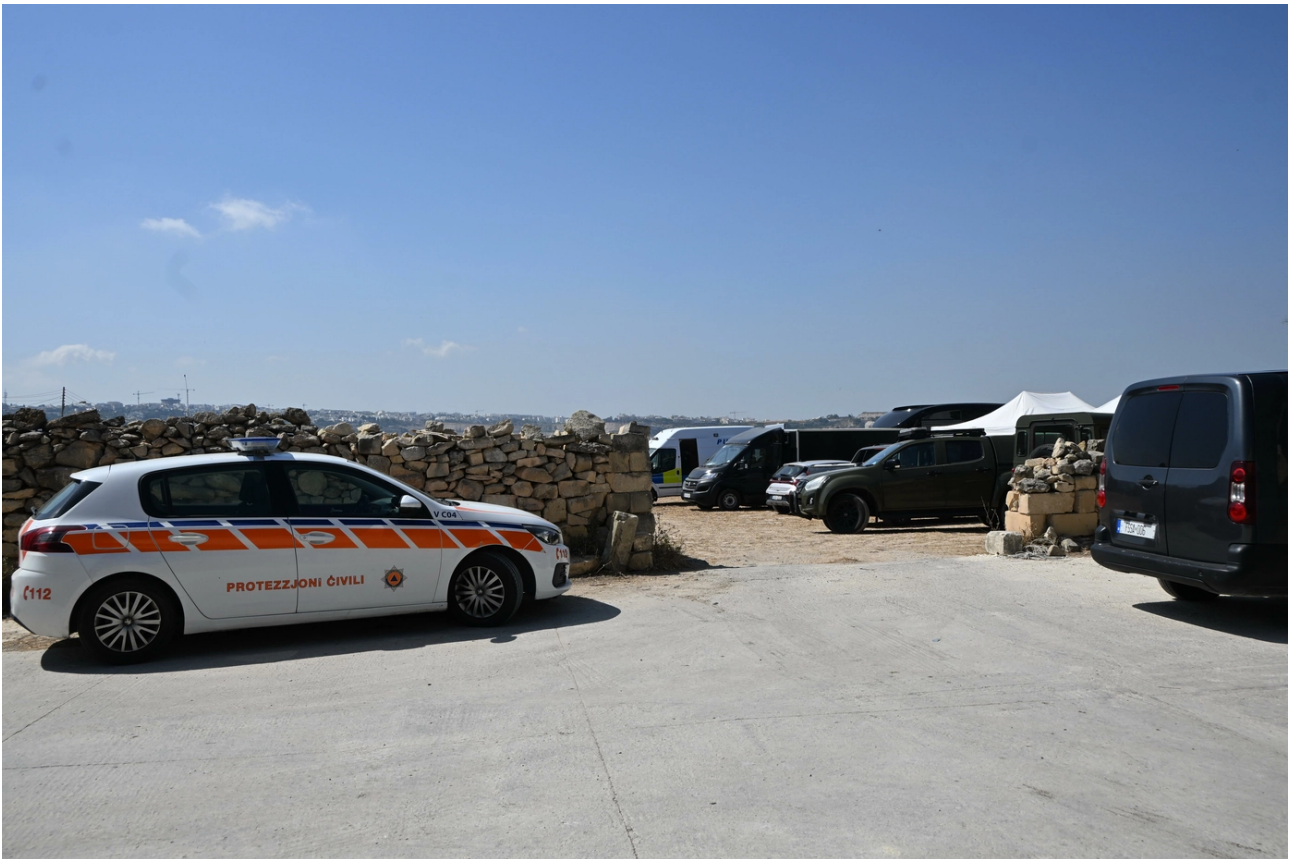
**Figure 7: Temporary multi-agency command and response area near the explosion site.**

General view photographed on 9 June 2026 showing the temporary operational presence near the restricted area, including Malta Police, Armed Forces of Malta Explosive Ordnance Disposal personnel, Civil Protection Department personnel, and other government departments or competent authorities. Relevant authorities may include the Food Safety and Security Authority, which is Malta's national body responsible for food safety and food-chain controls. The photograph records the visible external response area only and does not identify the full list of agencies present or their individual operational roles. Photograph: NatureMalta.com, 9 June 2026.

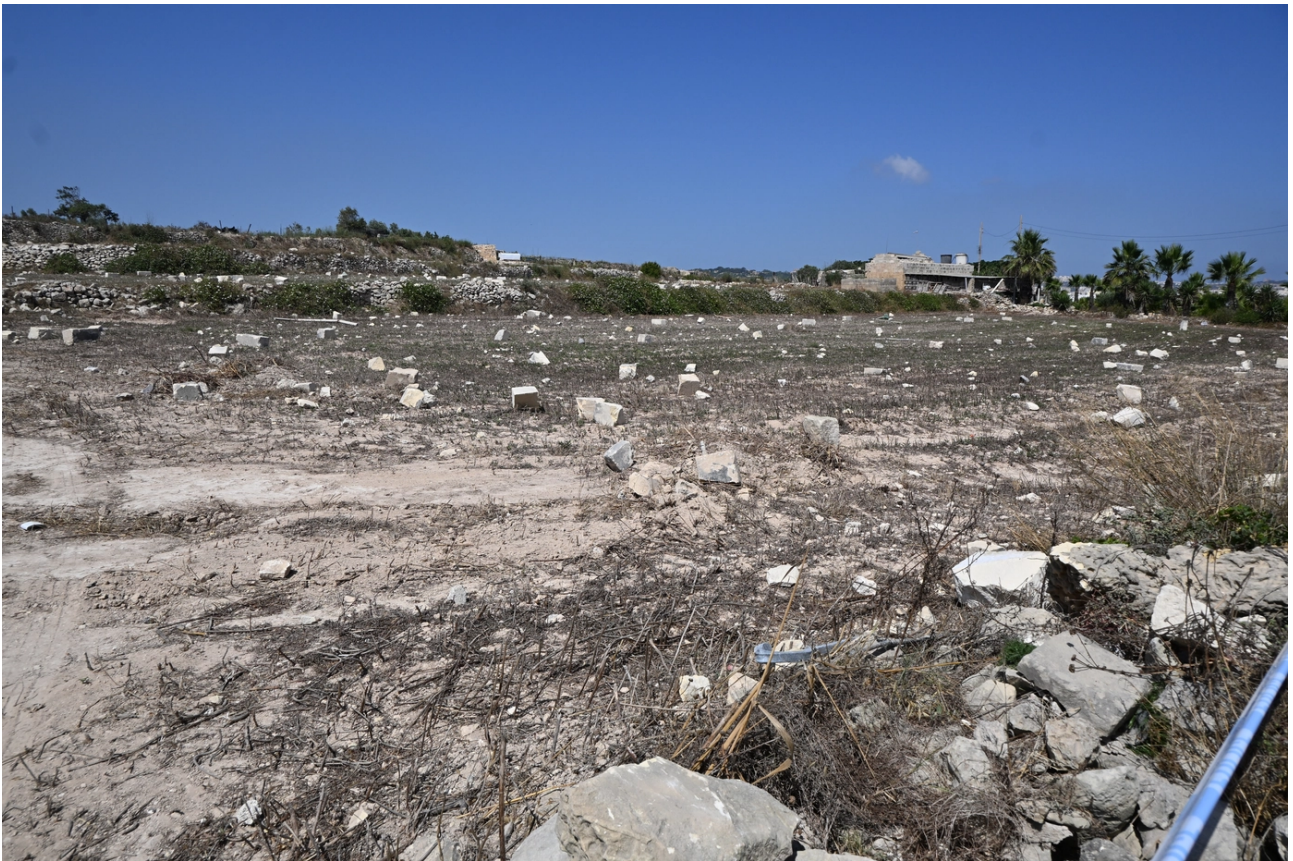
**Figure 8: Maltese limestone blocks dispersed across field near the cordoned perimeter.**

Maltese limestone blocks observed on 9 June 2026 scattered across a nearby field at the cordoned perimeter, approximately 200–250 metres from the reported centre of the explosion. The presence and distribution of the blocks provide visible external evidence of blast-related material dispersal across the surrounding rural area. The photograph records conditions visible from the accessible perimeter only and does not confirm the exact original position of the blocks or the full extent of material dispersal within the restricted inner area. Photograph: NatureMalta.com, 9 June 2026.

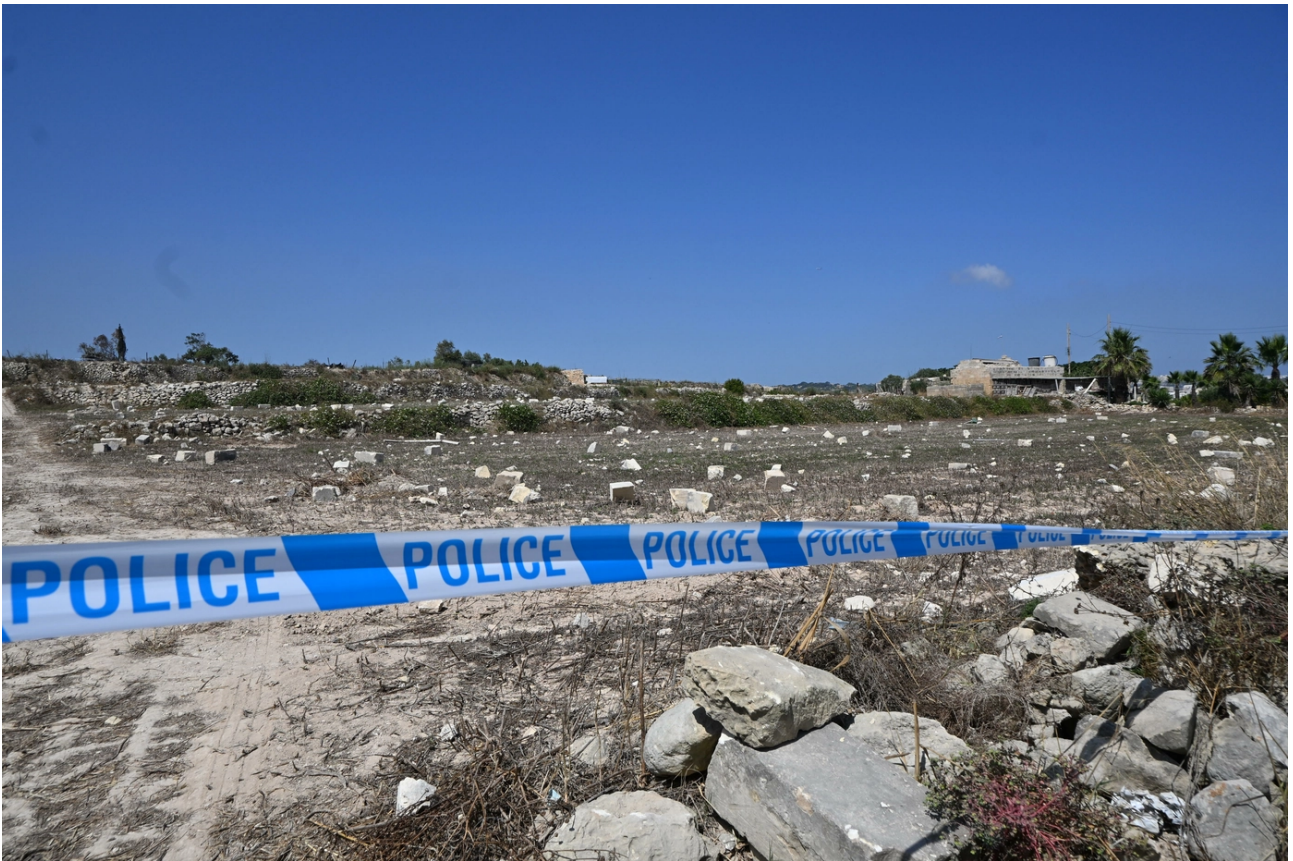
**Figure 9: Dispersed Maltese limestone blocks near police cordon, approximately 200–250 metres from the explosion centre.**

View photographed on 9 June 2026 showing Maltese limestone blocks scattered across a nearby field, with police cordon tape marking the restricted perimeter approximately 200–250 metres from the reported centre of the explosion. The visible distribution of material appears to indicate blast-related dispersal towards the north-east, although the precise blast direction, original location of the blocks, and full dispersal pattern would require official blast mapping and specialist assessment. The photograph records visible external evidence from the accessible perimeter only. Photograph: NatureMalta.com, 9 June 2026.

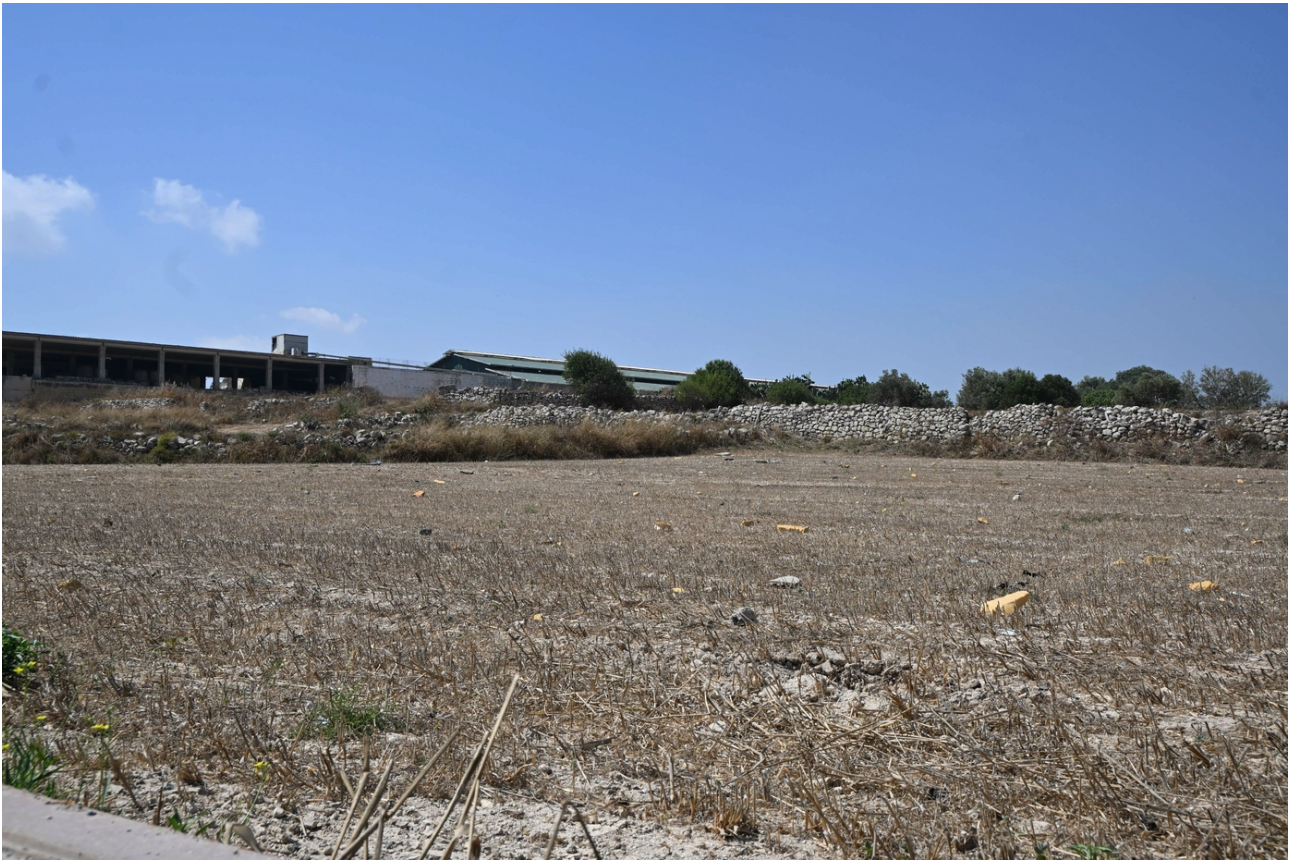
**Figure 10: Plastic, hard foam and insulation materials dispersed across local fields.**

View photographed on 9 June 2026 showing plastic fragments, hard foam and insulation-type materials dispersed across nearby fields following the 1 June 2026 explosion. The visible spread of lightweight materials indicates blast-related material dispersal beyond the immediate explosion site and presents a potential physical waste and cleanup concern for surrounding rural land. The photograph records visible external evidence from accessible areas only and does not confirm the source, chemical composition, contamination status, or full extent of dispersed material within the restricted area. Photograph: NatureMalta.com, 9 June 2026.

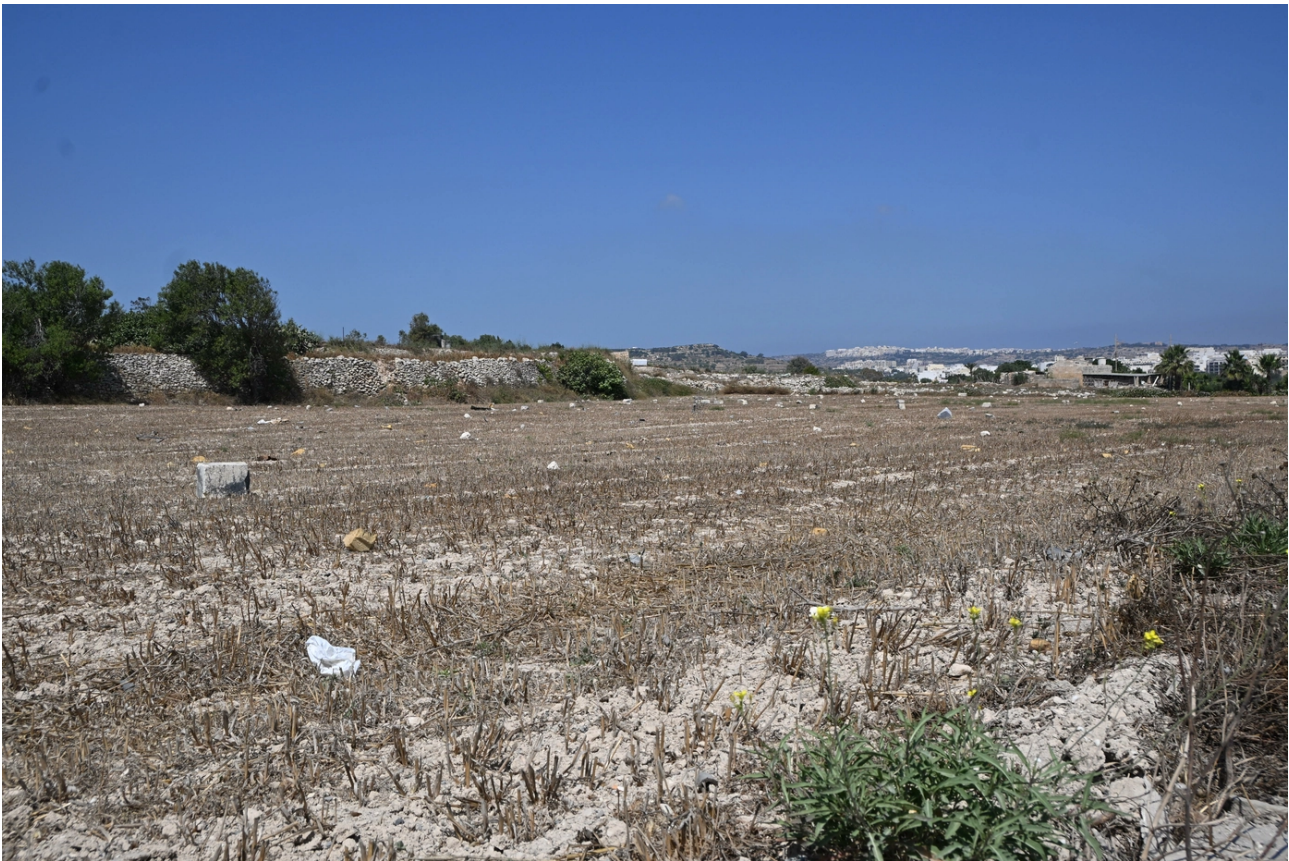
**Figure 11: Further view of dispersed plastic, hard foam and insulation-type debris across local fields.**

Additional view photographed on 9 June 2026 showing plastic fragments, hard foam and insulation-type materials scattered across nearby rural land following the 1 June 2026 explosion. This photograph provides further visual evidence of lightweight material dispersal beyond the immediate explosion site and supports the need for systematic debris clearance from affected fields. The photograph records visible external evidence from accessible areas only and does not confirm the source, chemical composition, contamination status, or full extent of dispersed material within the restricted area. Photograph: NatureMalta.com, 9 June 2026.

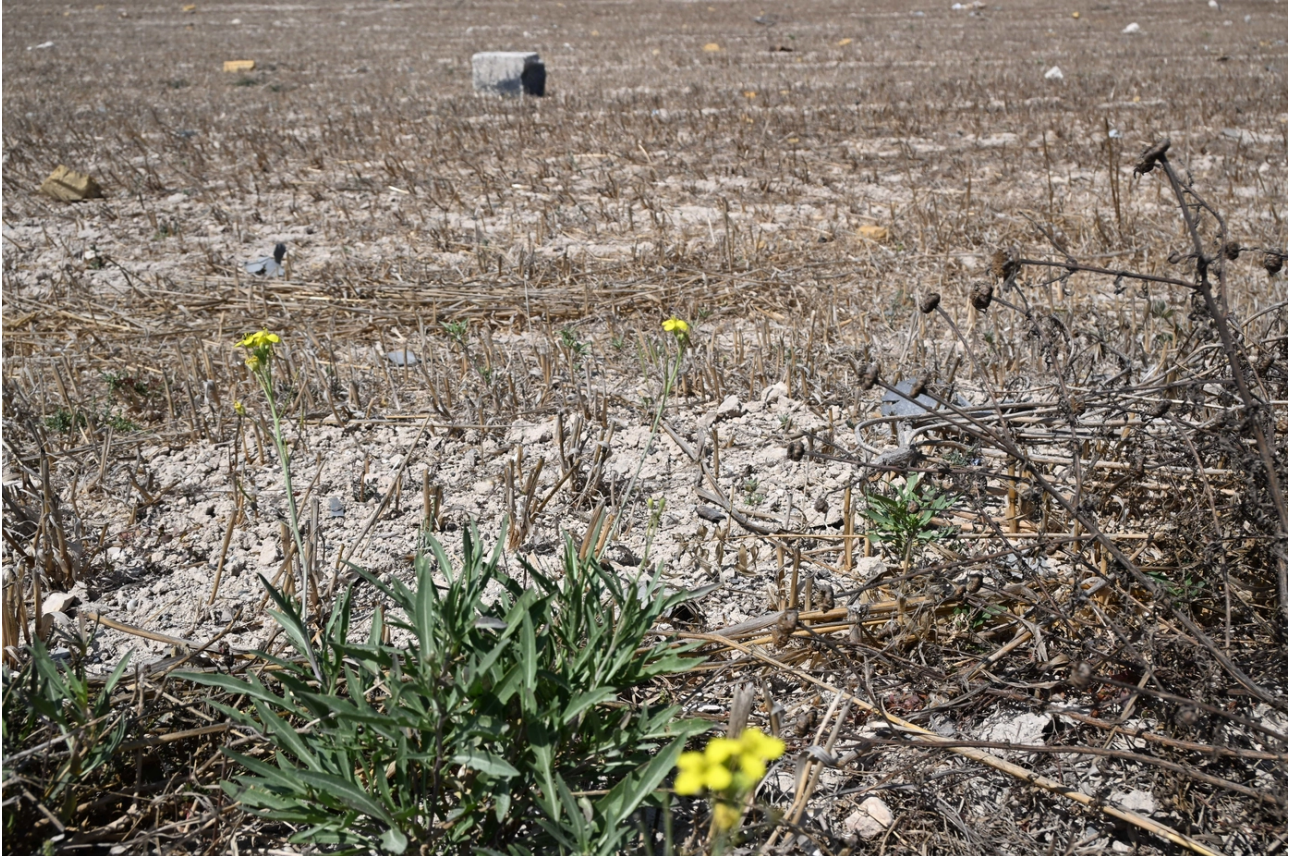
**Figure 12: Burnt firework casing and paper fragments scattered across local fields.**

View photographed on 9 June 2026 showing small burnt fragments of apparent firework casing material and paper scattered widely across nearby fields following the 1 June 2026 explosion. The visible distribution of burnt paper and casing fragments provides external evidence of pyrotechnic material dispersal beyond the immediate explosion site. The photograph records visible surface evidence from accessible areas only and does not confirm the chemical composition, contamination status, or full extent of firework-related residue within the restricted area. Photograph: NatureMalta.com, 9 June 2026.

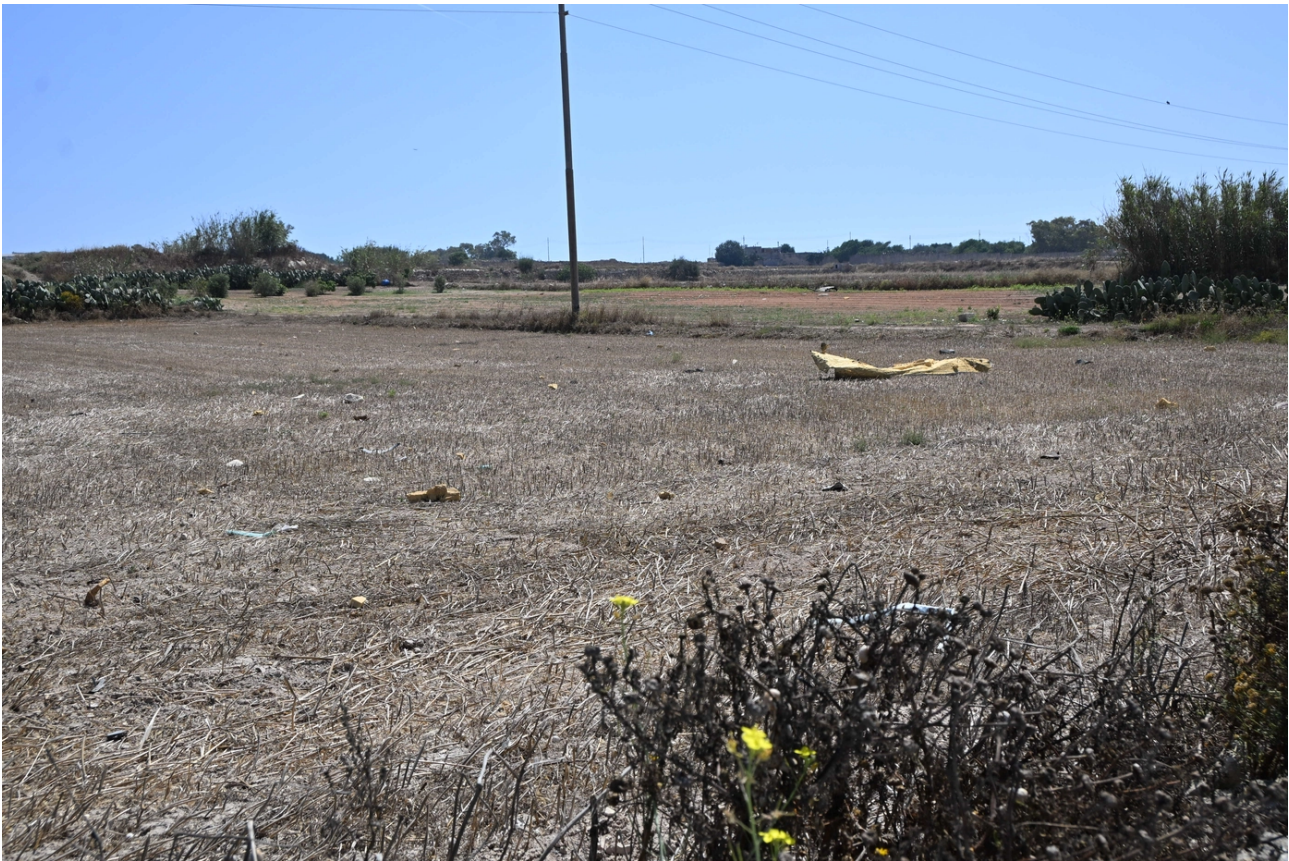
**Figure 13: Blast-dispersed materials observed beyond the 250-metre restricted radius.**

View photographed on 9 June 2026 showing dispersed materials outside the approximate 250-metre restricted radius, with visible debris extending beyond 300 metres from the reported centre of the explosion. The photograph provides external visual evidence that blast-related material dispersal was not confined to the immediate restricted area. The image records visible surface evidence from accessible areas only and does not confirm the full dispersal boundary, source of each material, chemical composition, or contamination status. Photograph: NatureMalta.com, 9 June 2026.

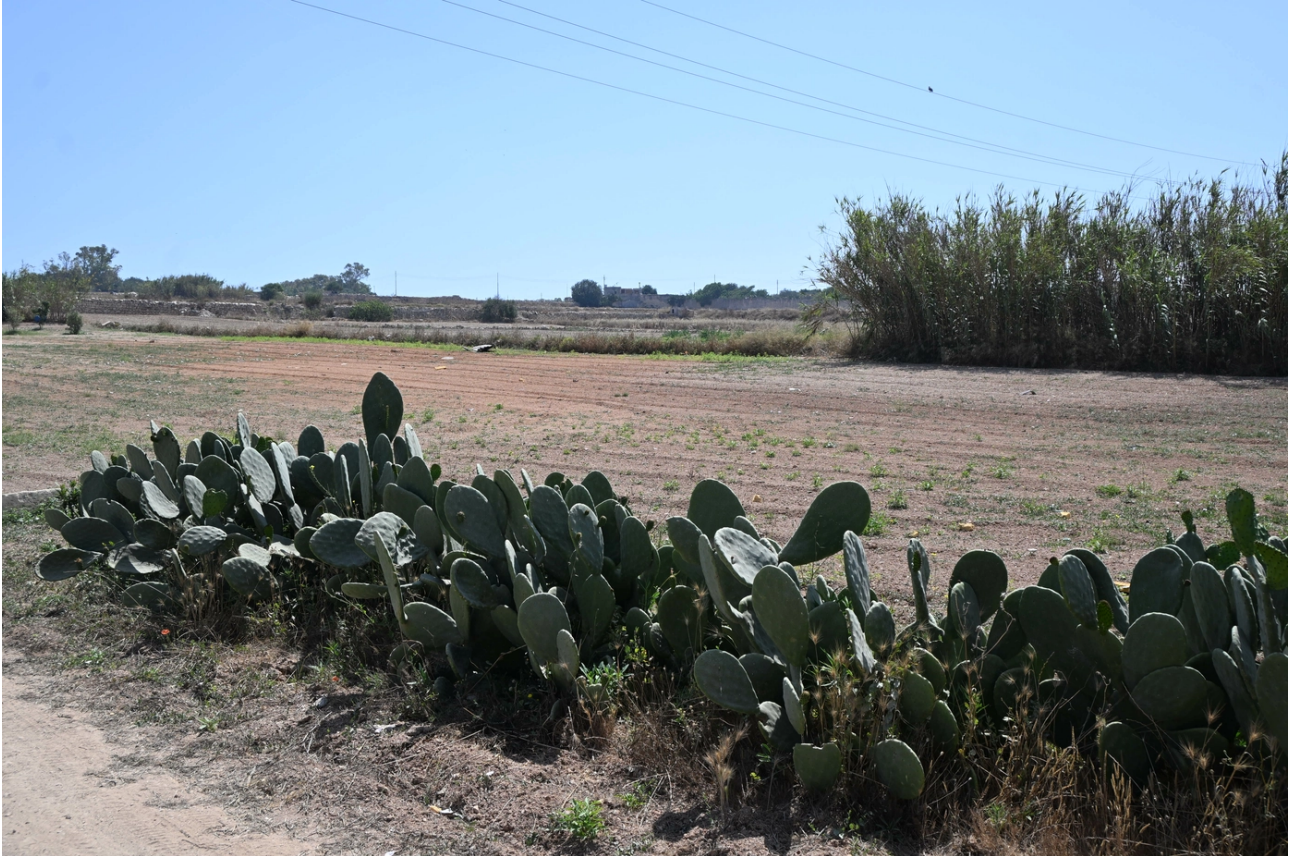
**Figure 14: Additional view of blast-dispersed materials beyond the 250-metre restricted radius.**

Additional view photographed on 9 June 2026 showing dispersed materials outside the approximate 250-metre restricted radius, with visible debris extending beyond 300 metres from the reported centre of the explosion. This photograph provides further external visual evidence that blast-related material dispersal extended beyond the immediate restricted area. The image records visible surface evidence from accessible areas only and does not confirm the full dispersal boundary, source of each material, chemical composition, or contamination status. Photograph: NatureMalta.com, 9 June 2026.

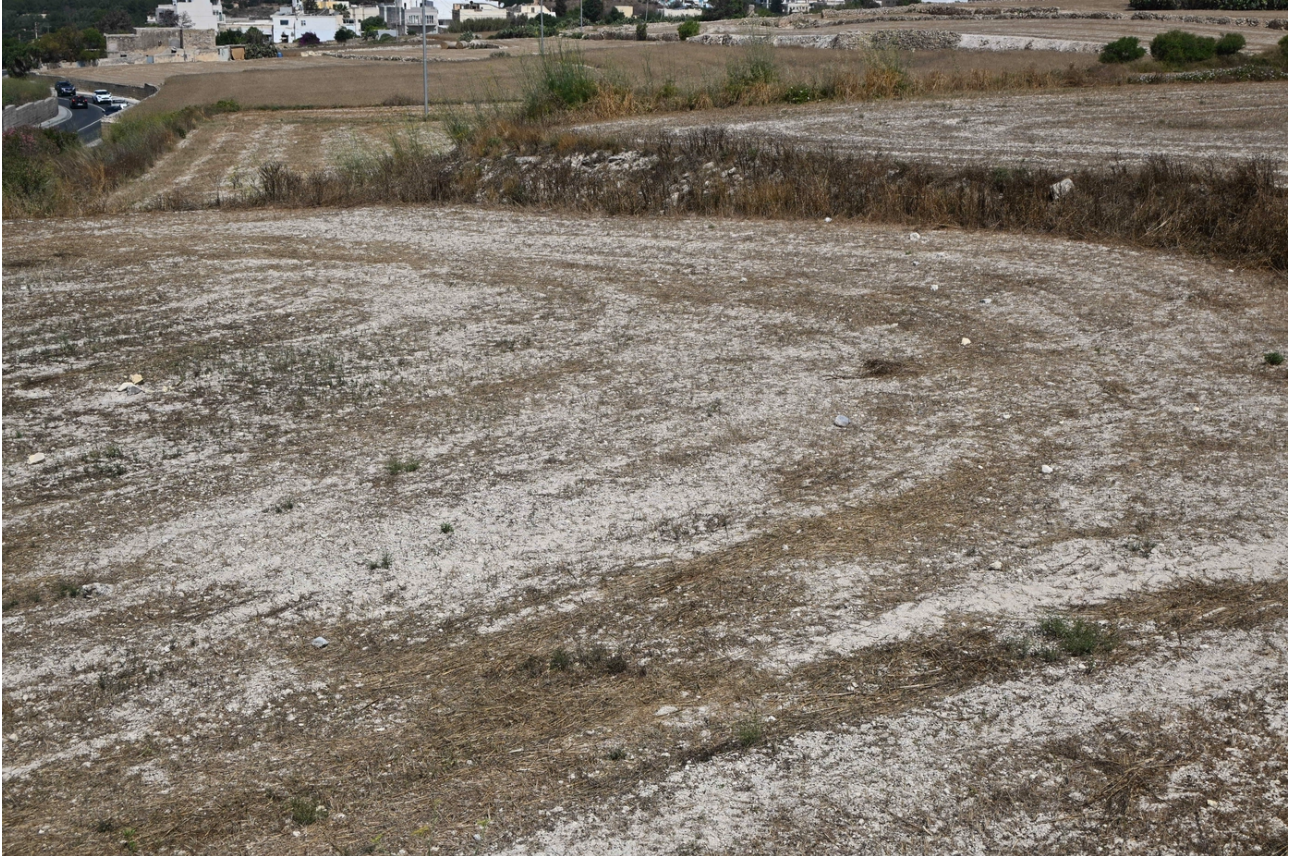
**Figure 15: Small Maltese limestone fragments observed approximately 400 metres from the blast area.**

View photographed on 9 June 2026 showing small Maltese limestone fragments lying in tilled agricultural fields approximately 400 metres from the reported centre of the explosion. The presence of stone fragments at this distance provides external visual evidence of blast-related material dispersal across surrounding rural land. The photograph records visible surface evidence from accessible areas only and does not confirm the original location of the fragments, exact trajectory, chemical contamination status, or full extent of the dispersal field. Photograph: NatureMalta.com, 9 June 2026.
